AFWAL-TR-81-2023

HIGH VOLTAGE TESTING

W.G. Dunbar
Boeing Aerospace Company
P.O. Box 3999
Seattle, Washington 98124

Interim Report for Period 24 September 1979 - 20 January 1981

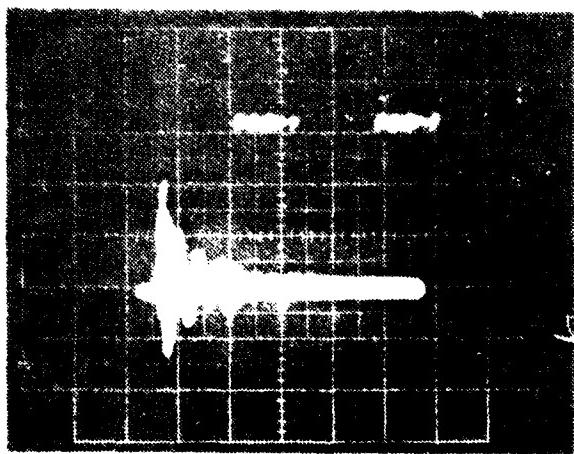
Photographs of good insulation integrity and breakdown are shown in Figures 6.4-1 and 6.4-2. Breakdown is indicated by loss of the original wave shape, such as an oscillation.

*Figure 6.4-2: Generator Coil, D-1 Negative Surge Failure;
Vertical: 2kV/div, Horizontal: 500ns/div.*

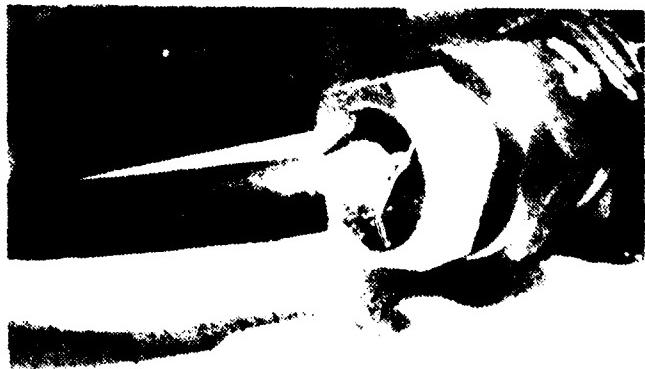
The second cable assembly A-4 also failed the surge test. Following the test, the cable was examined for visual failure. Found was a smokey haze on the connector termination. The termination was unassembled and the parts examined. In Figures 6.5-4 and 6.5-5 are shown the inner surface of the connector shell and the braid. Both show indications of the internal insulation failure. The insulation was badly charred between the braid and inner conductor.

Figure 6.5-5. Failure Occurred Between Braid and Center Conductor

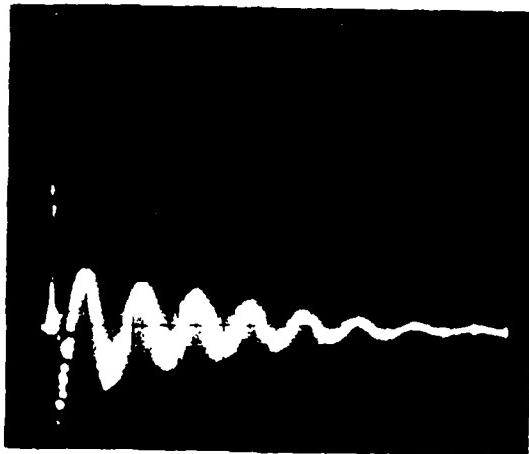
The oscillograms show that the cable broke down at 75 KV. (See figures 1 and 2).

Figure 1. Vertical: 25 KV/div Horizontal: 5 μ sec/div
Oscillogram of First Shot onto Cable Assembly (~75 KV).

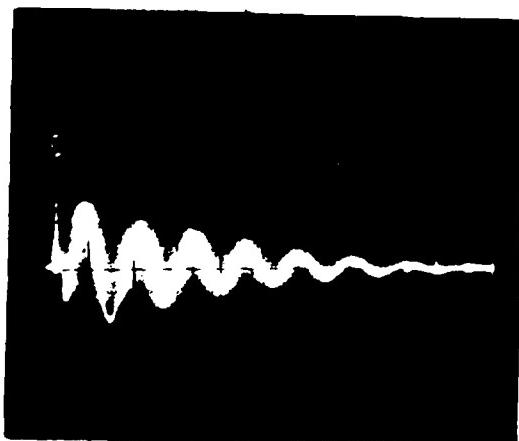
Figure 2. Vertical: 25 KV/div Horizontal: 5 μ sec/div
Oscillogram of #2 shot to Cable Assembly with
#1 Breakdown Point Put in Liquid Freon. (~75 KV)

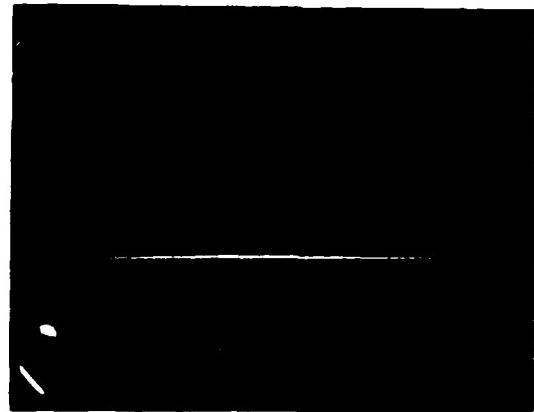
Figure 4. Vertical: 20KV/div Horizontal: 2 μ sec/div
A Repeat of Shot #3 to Verify Voltage Level(\approx 34KV).

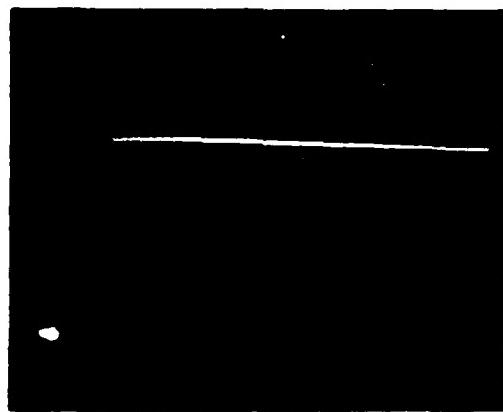
Figure 5. Vertical: 10 KV/div Horizontal: 2 μ sec/div
Increased Voltage Applied to Connector Assembly
and Cable Open End in Freon (\approx 45 KV).

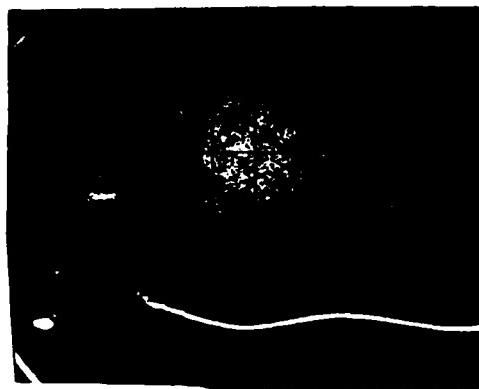
Figure 6. Vertical: 20 KV/div Horizontal: 2 μ sec/div
Breakdown Voltage Waveform on the Connector
and Cable Assembly with Open End of Cable in
Freon. (\approx 60 KV).

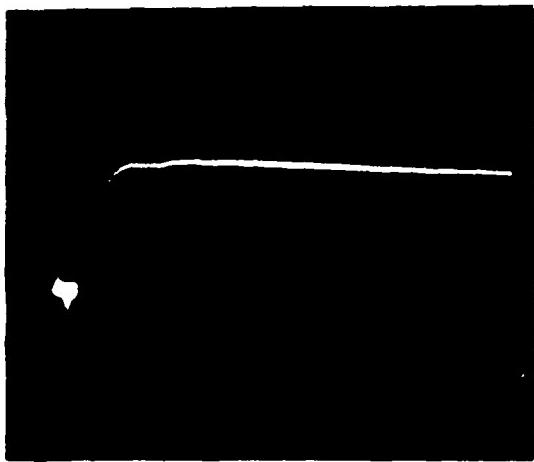
The initial test level on this capacitor was just under 60 KV. Due to previous corona testing it was felt that some dielectric polarization had taken place; since the B-2 capacitor had gone at such a low voltage. Thus the negative end of the capacitor was attached to the Marx. The Marx was being fired with a negative pulse. Figures 7-11 show the applied voltage

Figure 7. Vertical: 20 KV/div Horizontal: 2 μ sec/div
Initial Pulse Applied to Capacitor B-2
Peaking at Approximately 58 KV.

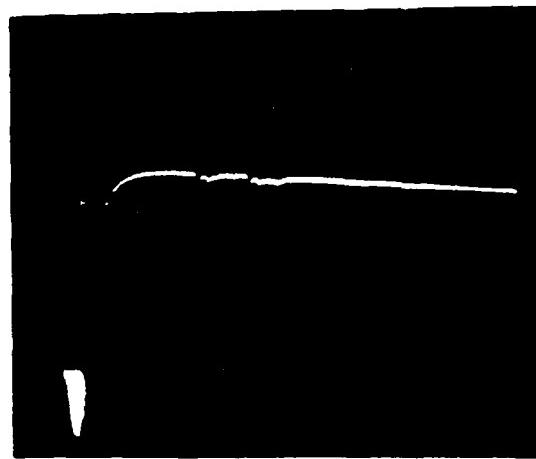
Figure 8. Vertical: 20 KV/div Horizontal: 2 μ sec/div
Second Level of Applied Voltage to Capacitor
B-2 Peaking at ~92 KV. Note: Slight
Breakup in Decay Side of Waveform.

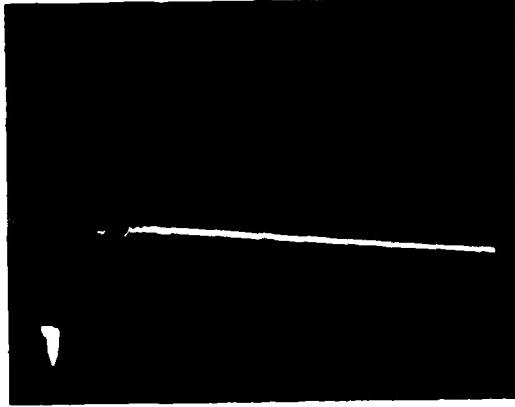
Figure 9. Vertical: 50 KV/div Horizontal: 2 μ sec/div
Third Voltage Level Applied to B-2
Peak Voltage \approx 110 KV. No Break up of Waveform
Noted.

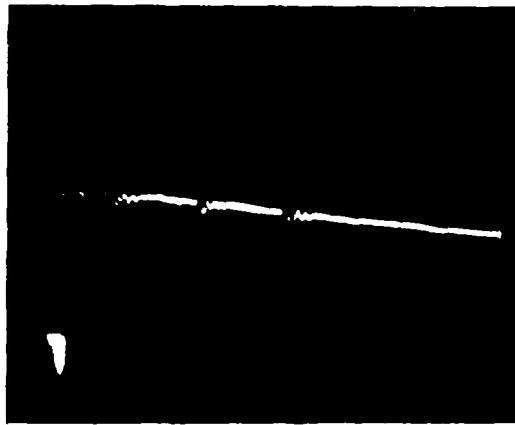
Figure 10. Vertical: 50 KV/div Horizontal: 2 μ sec/div
Fourth Level of Applied Voltage to B-2
Peak Voltage \approx 155 KV. The Spiking Seen on the
Decay Side is Due to Observed Arcing in the
Discharge Circuit of the Marx Generator.

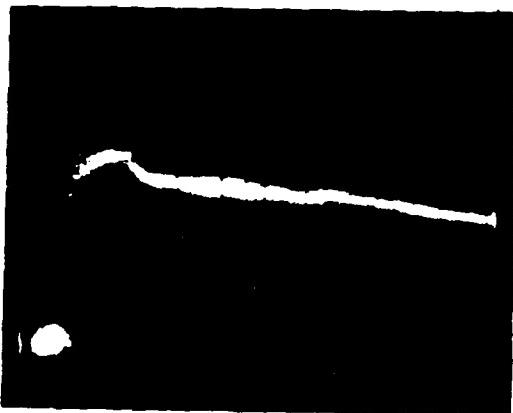
Figure 11. Vertical: 50 KV/div Horizontal: 2 μ sec/div
The Last Shot of Applied Impulse Voltage to Capacitor B-2 of Approximately 210 KV.
Note Just at the Peak the Waveform Breaks Up.
It was Felt That This Would be About The Upper Limit For the Dielectric Hold Off.

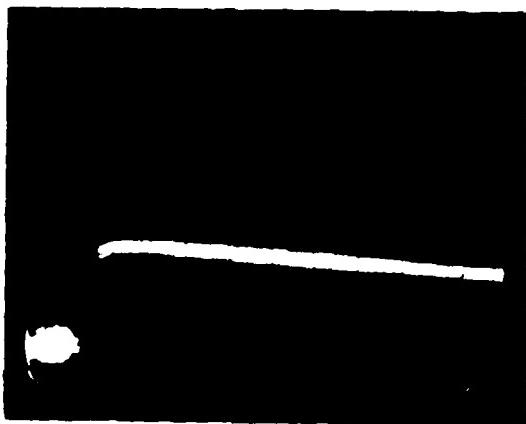
The capacitor was set up similarly to the B-2 and it was checked to ensure that the negatively static tested lead was attached to the Marx Generator output. The initial level was about 100 KV. (See Figures 12 and 13)

Figure 12. Vertical: 50 KV/div Horizontal: 2 μ sec/div
Initial Pulsed Voltage Waveform Applied to B-2 ~110 KV Peak.

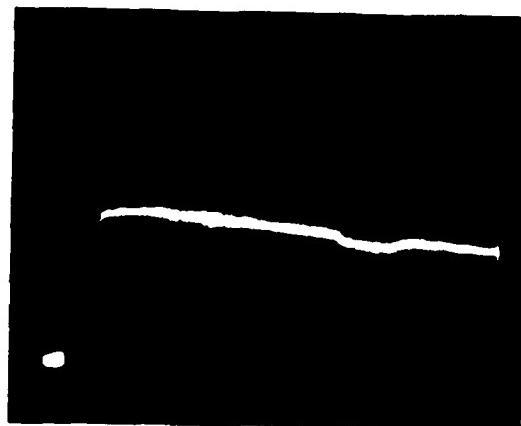
Figure 13. Vertical: 50 KV/div Horizontal: 2 μ sec/div
The Second and Last Voltage Waveform Applied
to B-1 with \approx 165 KV Peak.
The Reason for the Last Shot is the Break Up of
the Waveform Indicating That the Level is Close
to Breakdown of the Capacitor's Dielectric.

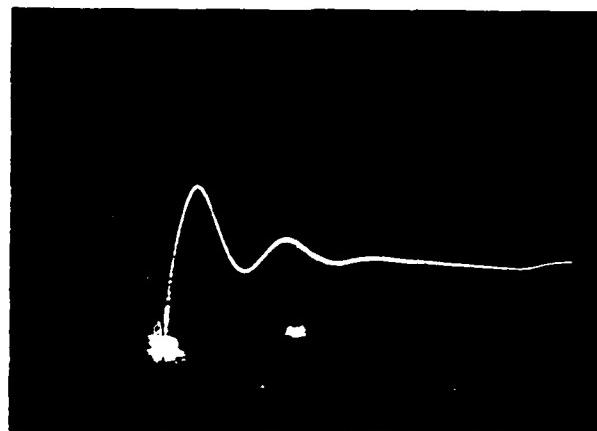
No specification on applied waveform was given, so a one microsecond front time with a 40-50 microsecond tail time was set up without the test capacitor added. Figure 15 shows the voltage waveform measured across the Hughes capacitor on the initial pulse of 7 KV.

Figure 15. Vertical: 2 KV/div Horizontal: 5 μ sec/div
The Oscillogram of the Pulsed Voltage Waveform Across the C-1, Serial #13 Capacitor, 7 KV Peak.

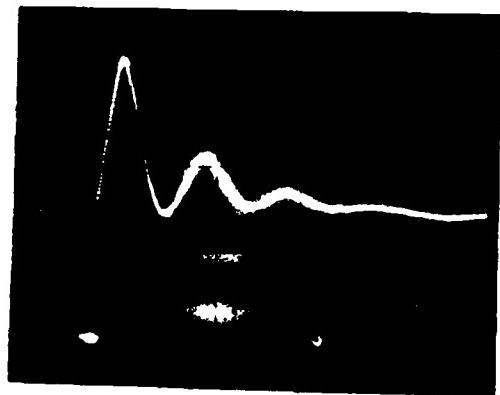
Figure 10 brings out an interesting waveform which may help determine the addition mechanism. The charge voltage on the 100 nfd capacitor was set for 10 KV.

Figure 10 Vertical: 2 KV/div Horizontal: 5 usec/div
The Oscillogram of the Impulse Voltage as Applied to Capacitor C-1, Serial #13. The
Voltage Peak at 12.5 KV. The Oscillation is
Present and After a Change in Rate-of-Rise of the
Waveform Can Be Seen.

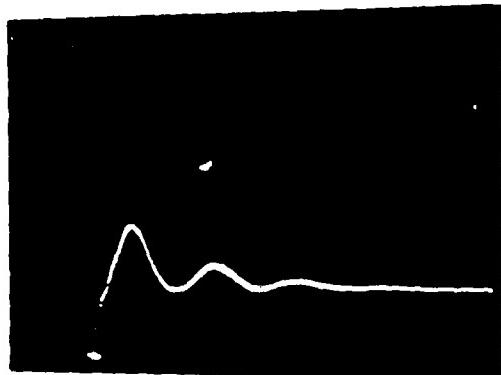
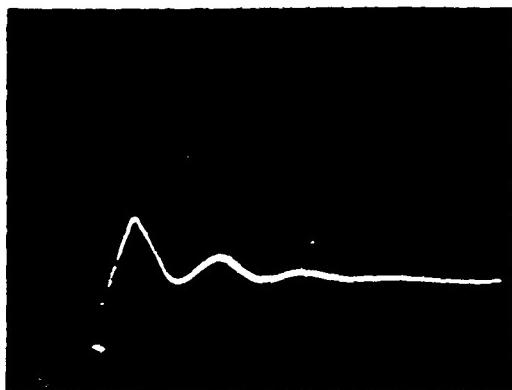
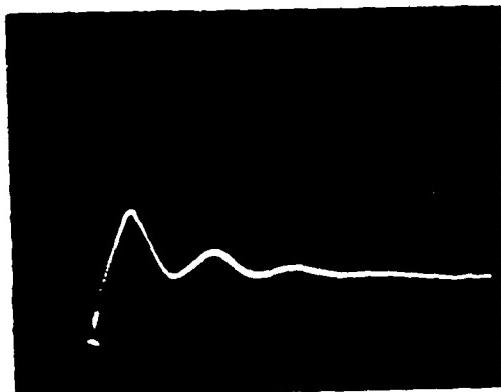
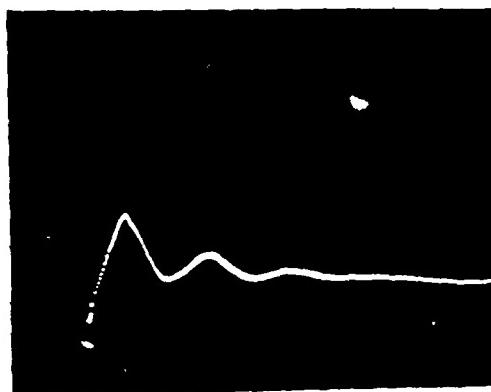
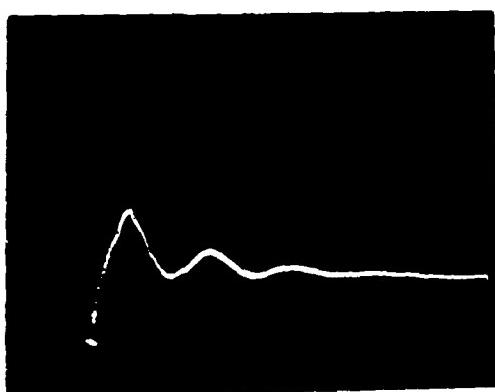
Figure 17. Vertical: 5 KV/div
Horizontal: 5 sec/div

The test circuit was determined to be correct, the change in rate-of-rise of the impulse voltage max. voltage of the pulse was measured. The series of three oscilloscopes were connected to the output of the test circuit. The time interval for the first and second sweep was 1 microsecond; the third sweep was 1 millisecond.

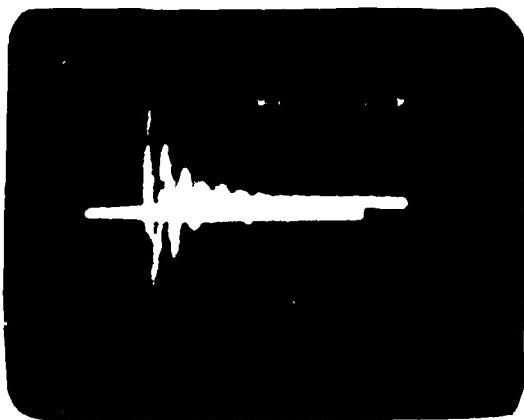
Generator Coil
Breakdown at 8.0
Vertical: 2000 V/div.
Horizontal: 500 ns/div.

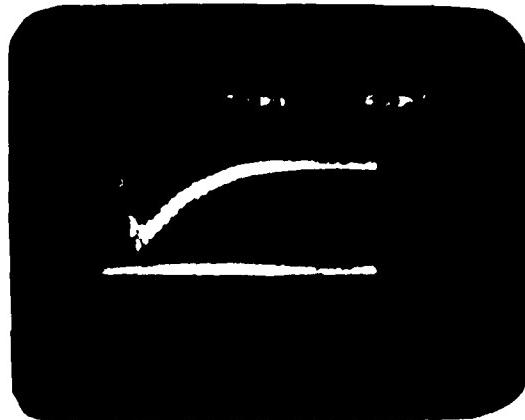
Generator Coil
1 Layer Insulation
Pass 8 KV
Vertical: 2000 V/div.
Horizontal: 500 ns/div.

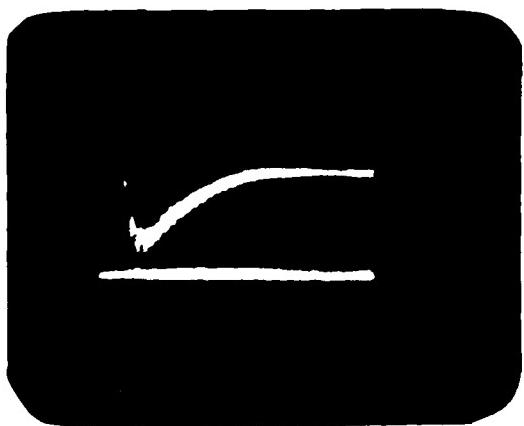
Generator Coil
1 Layer Insulation
Pass 8 KV
Vertical: 2000 V/div.
Horizontal: 500 ns/div.

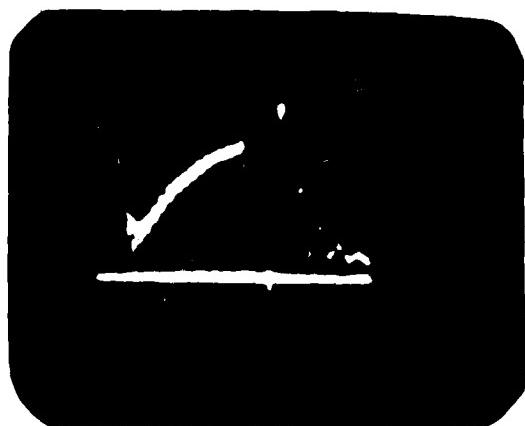
Generator Coil
1 Layer Insulation
Breakdown at 10 KV
Vertical: 2000 V/div.
Horizontal: 500 ns/div.

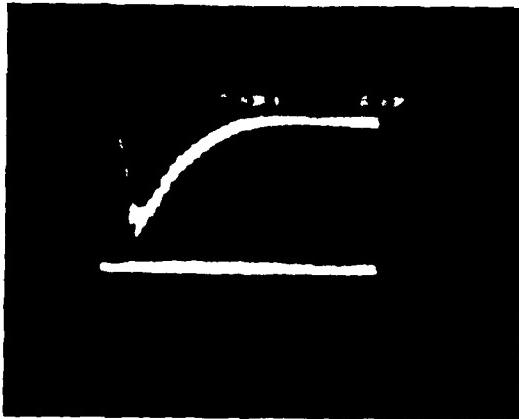
Generator Coil
2 Layers Insulation
Pass 11 KV
Vertical: 2000 V/div.
Horizontal: 500 ns/div.

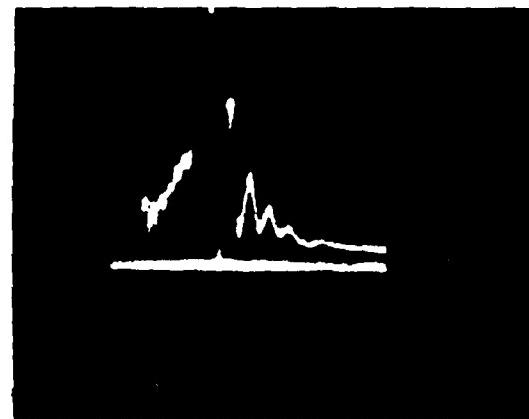
Generator Coil
2 Layers Insulation
Breakdown at 13 KV
Vertical: 2000 V/div.
Horizontal: 500 ns/div.

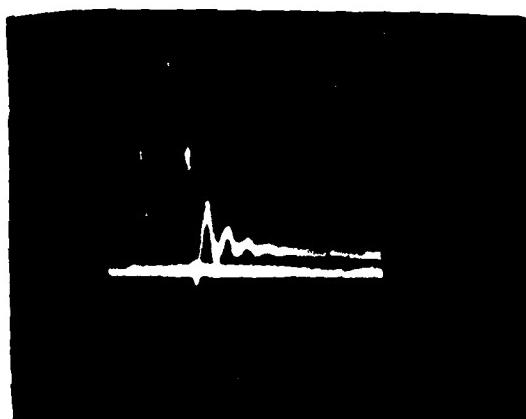
Generator Coil
3 Layers Insulation
Breakdown at 16 KV
Vertical: 2000 V/div.
Horizontal: 500 ns/div.

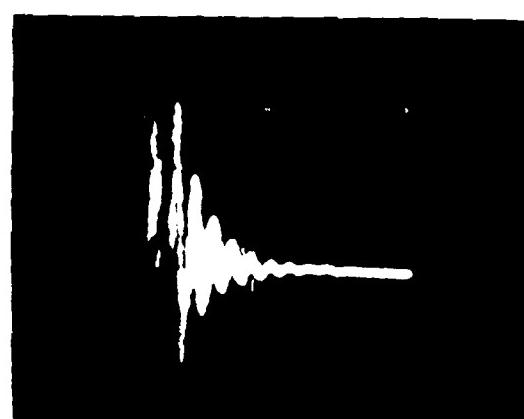
Generator Coil
3 Layers Insulation
Breakdown at 13 KV
Vertical: 2000 V/div.
Horizontal: 500 ns/div.
